## Application note

# Boroblending compressor blades

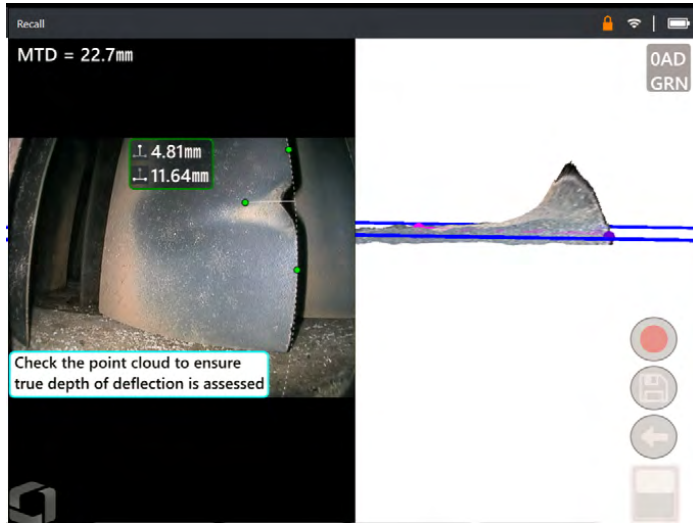
This image has captured damage to a compressor blade. It shows both the 2D (left) and 3D (right) split view on the MVIQ. Cursor placement of the full depth of deflected material significantly surpasses the initial visual assessment obtained from the 2D image alone.

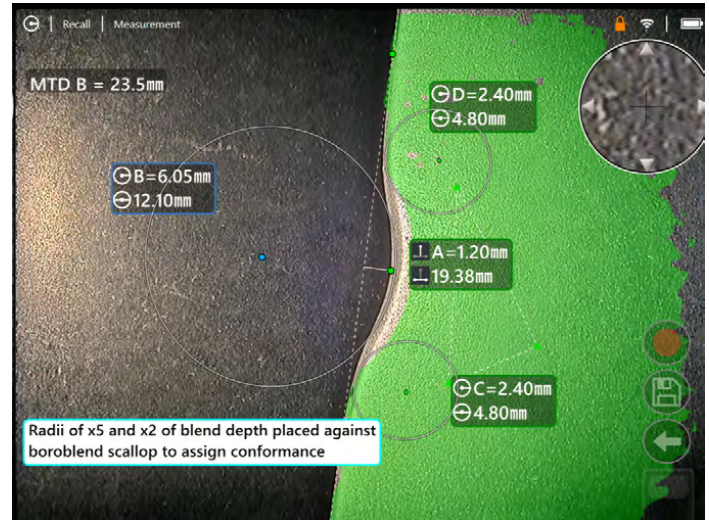
Here we have a Real 3D captured image of an aerofoil containing a boroblended site (derived from a different edge-breaking defect). This example requires the user to assign a measurement plane (using three cursors) to then enable the placement of the Radius Gauge into the free space off the surface of the actual component. The circles do not bisect the blended material; therefore, this blend is acceptable.

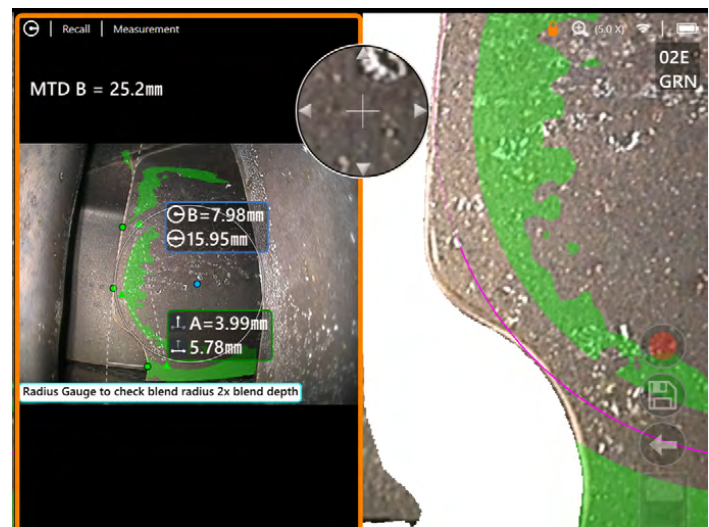
The next example shows a tip blend. A radius gauge circle is positioned over the "blend-out" position. It is sized to conform to a known acceptance radii for the well-known aero engine type. This bisects the blended material and therefore indicates that further material needs to be removed.

Highlighting material not conforming to radius line (magenta) therefore showing material that requires further removal in order to comply with acceptance criteria.
